30 December 2016

Reference: Walters Memorial A.M.E. Zion Church - Cursory Structural Conditions Assessment

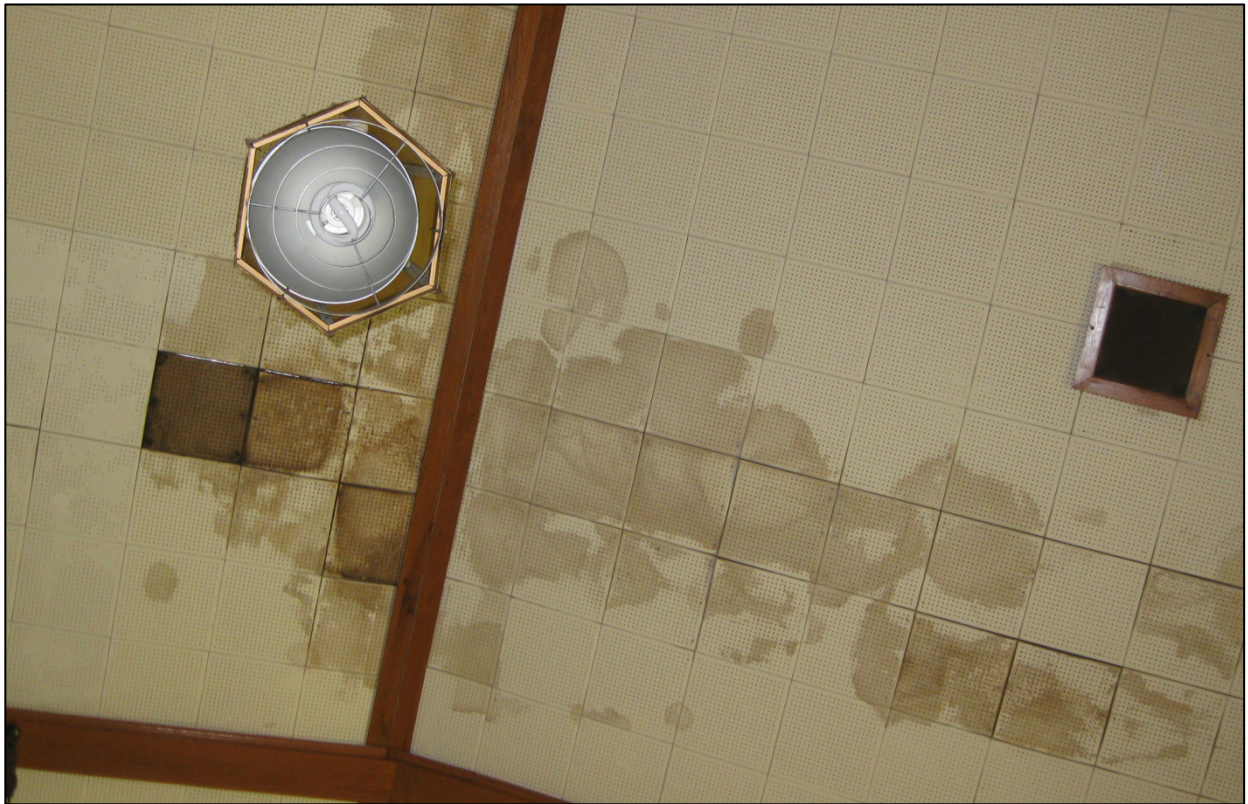
1. We accessed the attic space above a hatch at the east end of the church. Dimensional lumber rafters within sight appear to be sound and functioning as intended. An active roof leak at the western end of the church is apparent. We could not see these rafters from the access hatch at the east. Some localized deterioration of rafters may have occurred and the rafters should be accessed and checked.

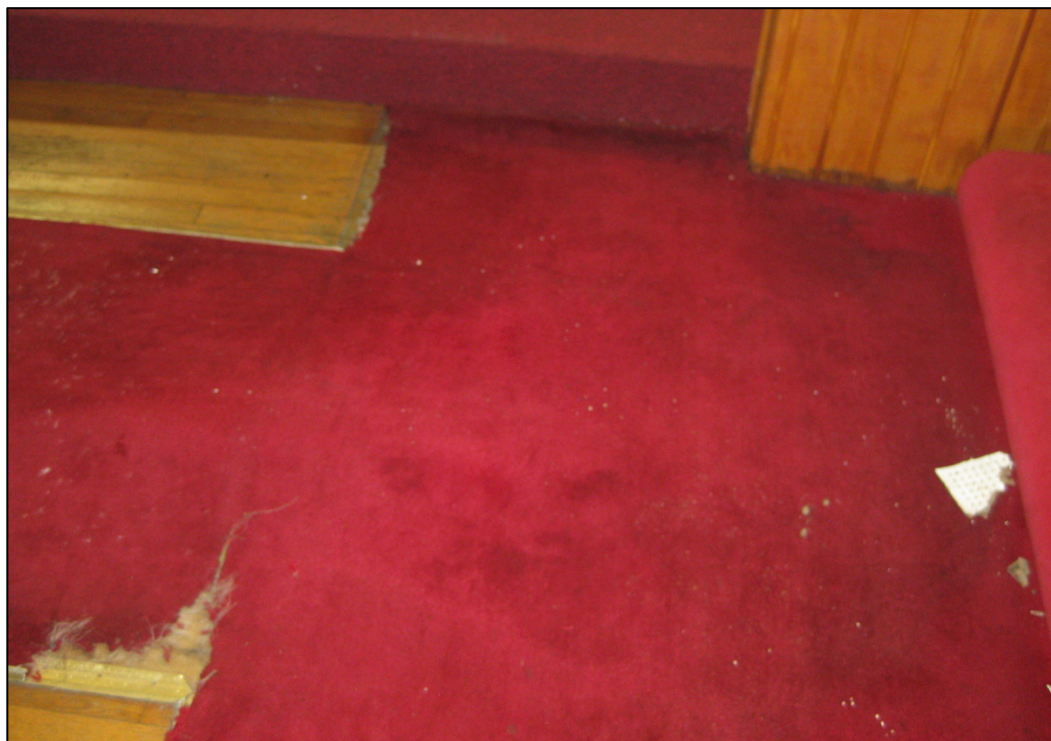
2. Buckling of first floor decking directly below roof leak will need to be repaired.

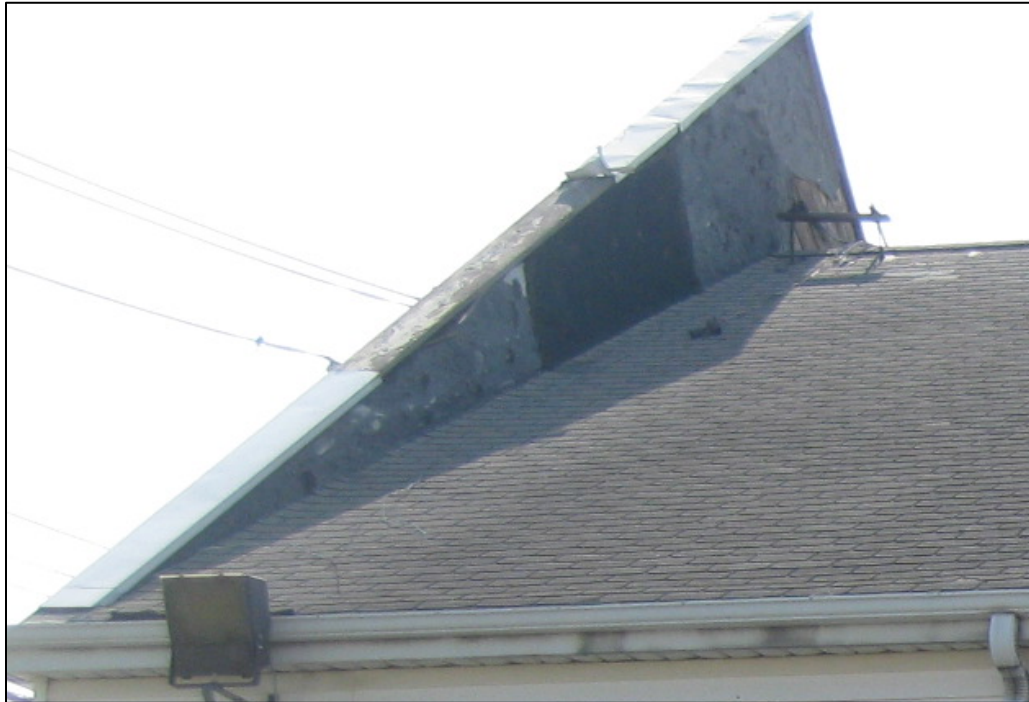
3. Front (east) parapet leaning back (west), needs further investigation and repair. Note that a section of the coping is missing, which can allow for potential moisture infiltration into the wall.

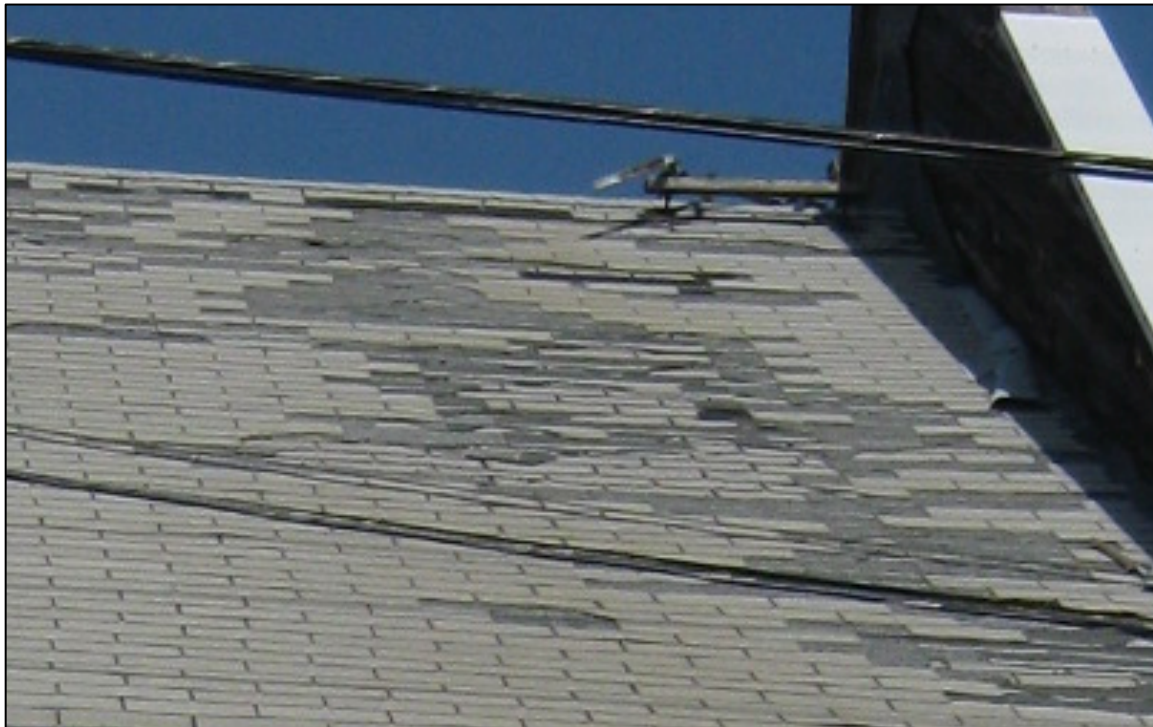
4. Multiple shingles on the east side of the roof in the vicinity of the parapet are missing or loose, and require replacement. There are several areas of the roof that exhibit similar conditions, and full roof replacement may be recommended pending further investigation. It is not clear whether an older layer of shingles is below.

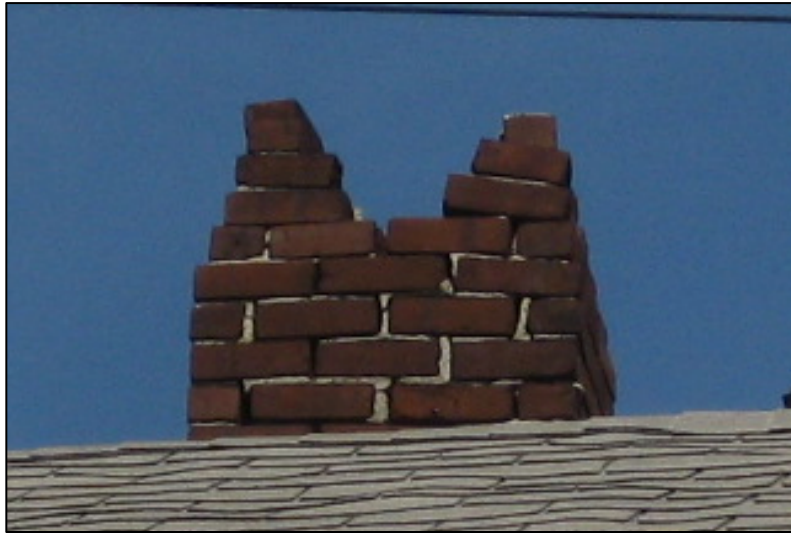
5. Severe mortar joint deterioration and potential displacement of brick masonry units at the parsonage chimney. Complete or partial rebuilding of the chimney is most likely required.

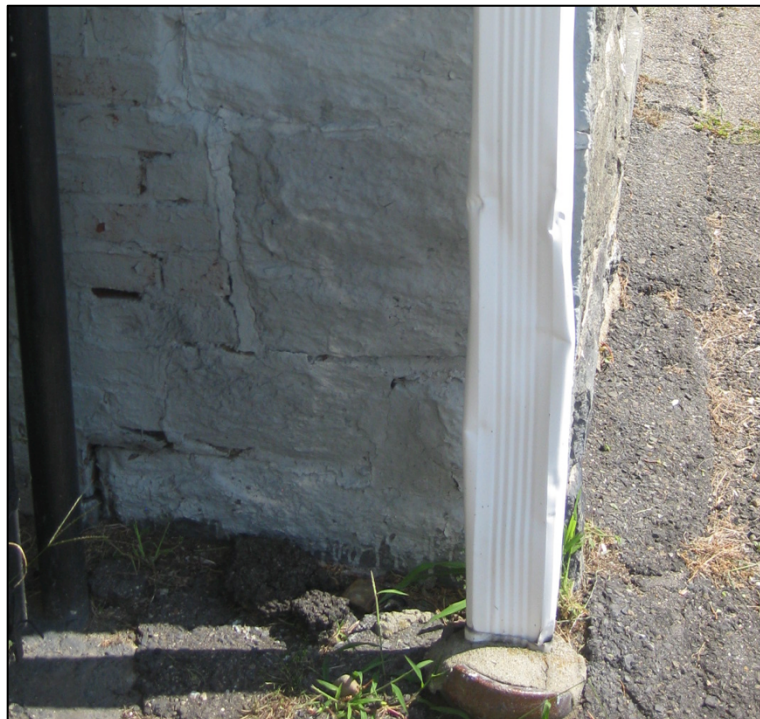
6. Side foundation wall has cracks and masonry deterioration near leaders indicating that the roof drainage system, consisting of gutters draining to leaders that extend to sub-grade drainage, is malfunctioning. The condition of the sub-grade drainage was not verified. Cleaning out of gutters and sub-grade leaders is required to maintain proper drainage and ensure that there is no back up resulting in potential water infiltration to the structure (basement). Overall cleaning of the gutters and associated drainage should be performed 2-3 times per year.

The rear foundation walls of the main church and brick foundation of the parsonage have been painted, presumably in an attempt to keep water out. If the applied coating is not breathable (many are not), it could be trapping moisture within the masonry walls and deteriorating the mortar.

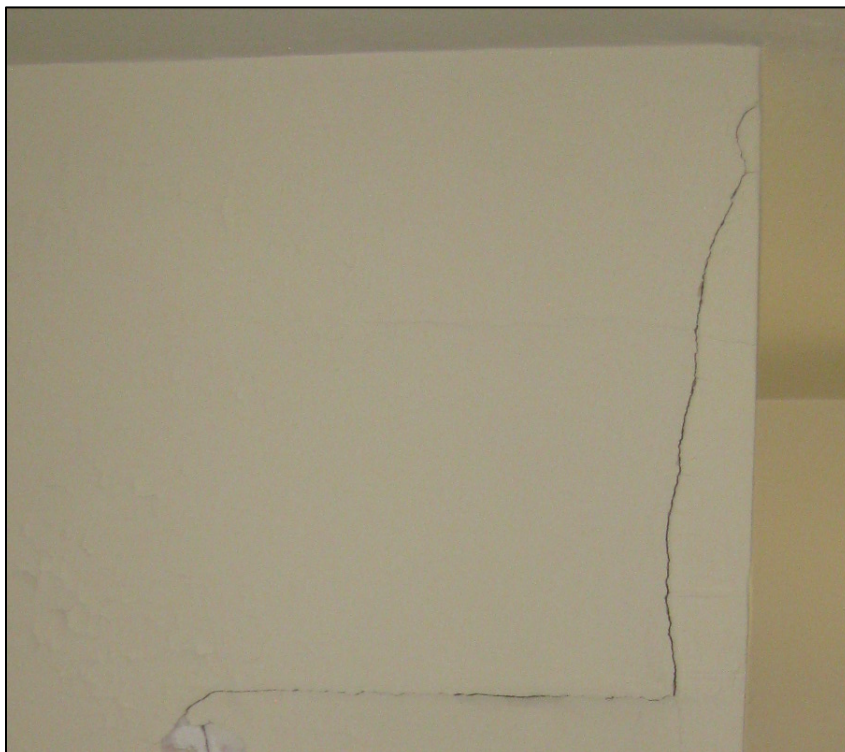
7. Parsonage cracking in and around interior walls of dormer is indicative of settlement in the wall or roof framing supporting the dormers. Additional investigation of surrounding roof framing is recommended.

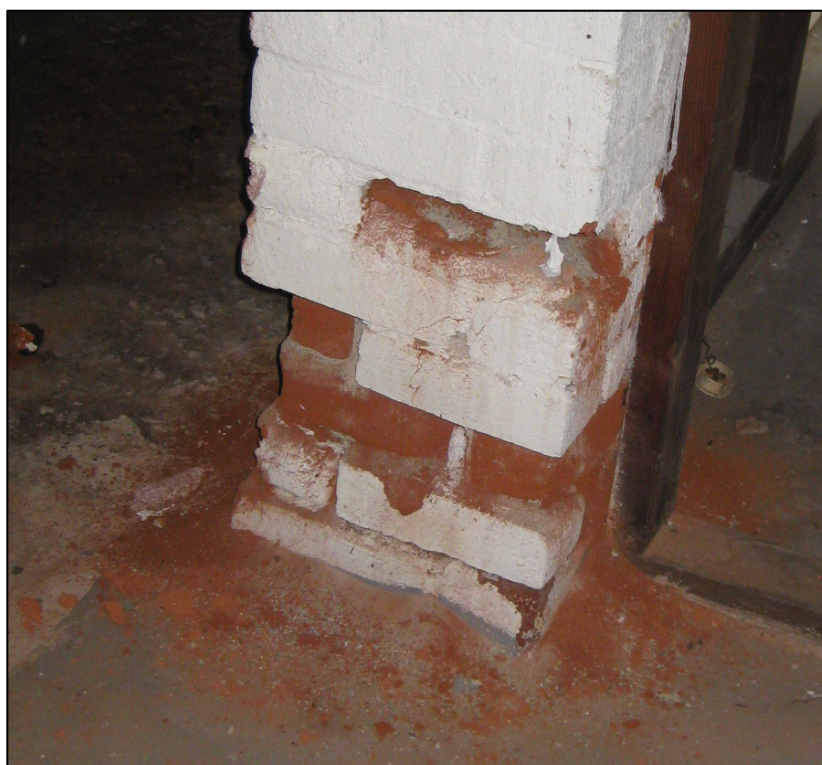
8. Rising damp in parsonage as evident by failed masonry coating and disintegrating brick masonry and mortar.

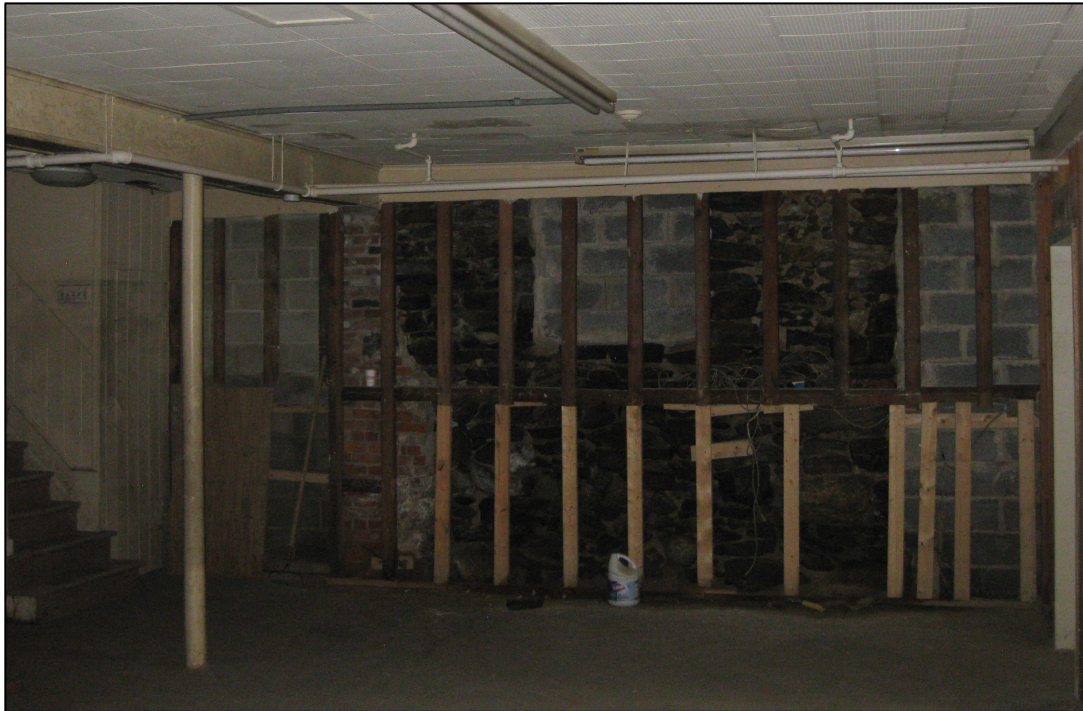
9. Flooding in church basement during Hurricane Sandy caused damage to finishes (since removed) and partition wall studs (the lower portion of which have been replaced).
