*Photograph Mounted*  
*Drawing Mounted*HISTORIC RESOURCES INVENTORY FORM  
for Buildings and Structures

1. BUILDING NAME: Common: \_\_\_\_\_ Historic: W.H. Bunce
2. STREET & NUMBER: 34 Bidwell St.
3. OWNER: R. Schiller PUBLIC \_\_\_\_\_ PRIVATE \*
4. USE: Present: residence Historic: residence

## HISTORIC AMERICAN BUILDINGS SURVEY INVENTORY

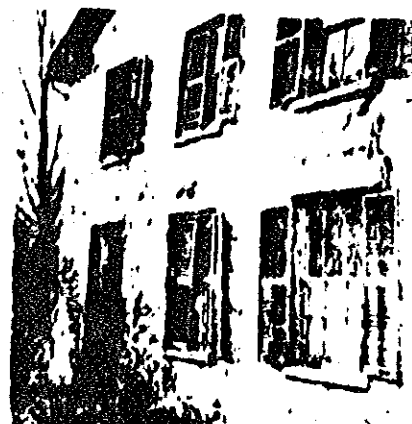
This house is very fine in ashlar masonry, with very good classic wood trim, and wood ell. The house has a great deal of character and is one of the very few stone houses in the Town of Manchester. The house is in poor condition although the stone work seems to be in quite good condition.

This house is greatly endangered, if not doomed, because the new Route 6 highway is apparently going right through it. As a matter of fact, the surveyors were working on it recorded this house.
